Monthly Oversight Report 56
44728 AES [46526 RAC]
ACS NPL Site
Griffith, Indiana
August 6, 2005 – September 2, 2005

Subject: Monthly Oversight Summary Report
No. 56 for August 2005

Monthly Oversight Summary Report No. 56
ACS Superfund Site
TO 057, 44728.238 AES [WA57, 46526.238 RAC]

Reporting Period: Month of August (August 6, 2005 – September 2, 2005)

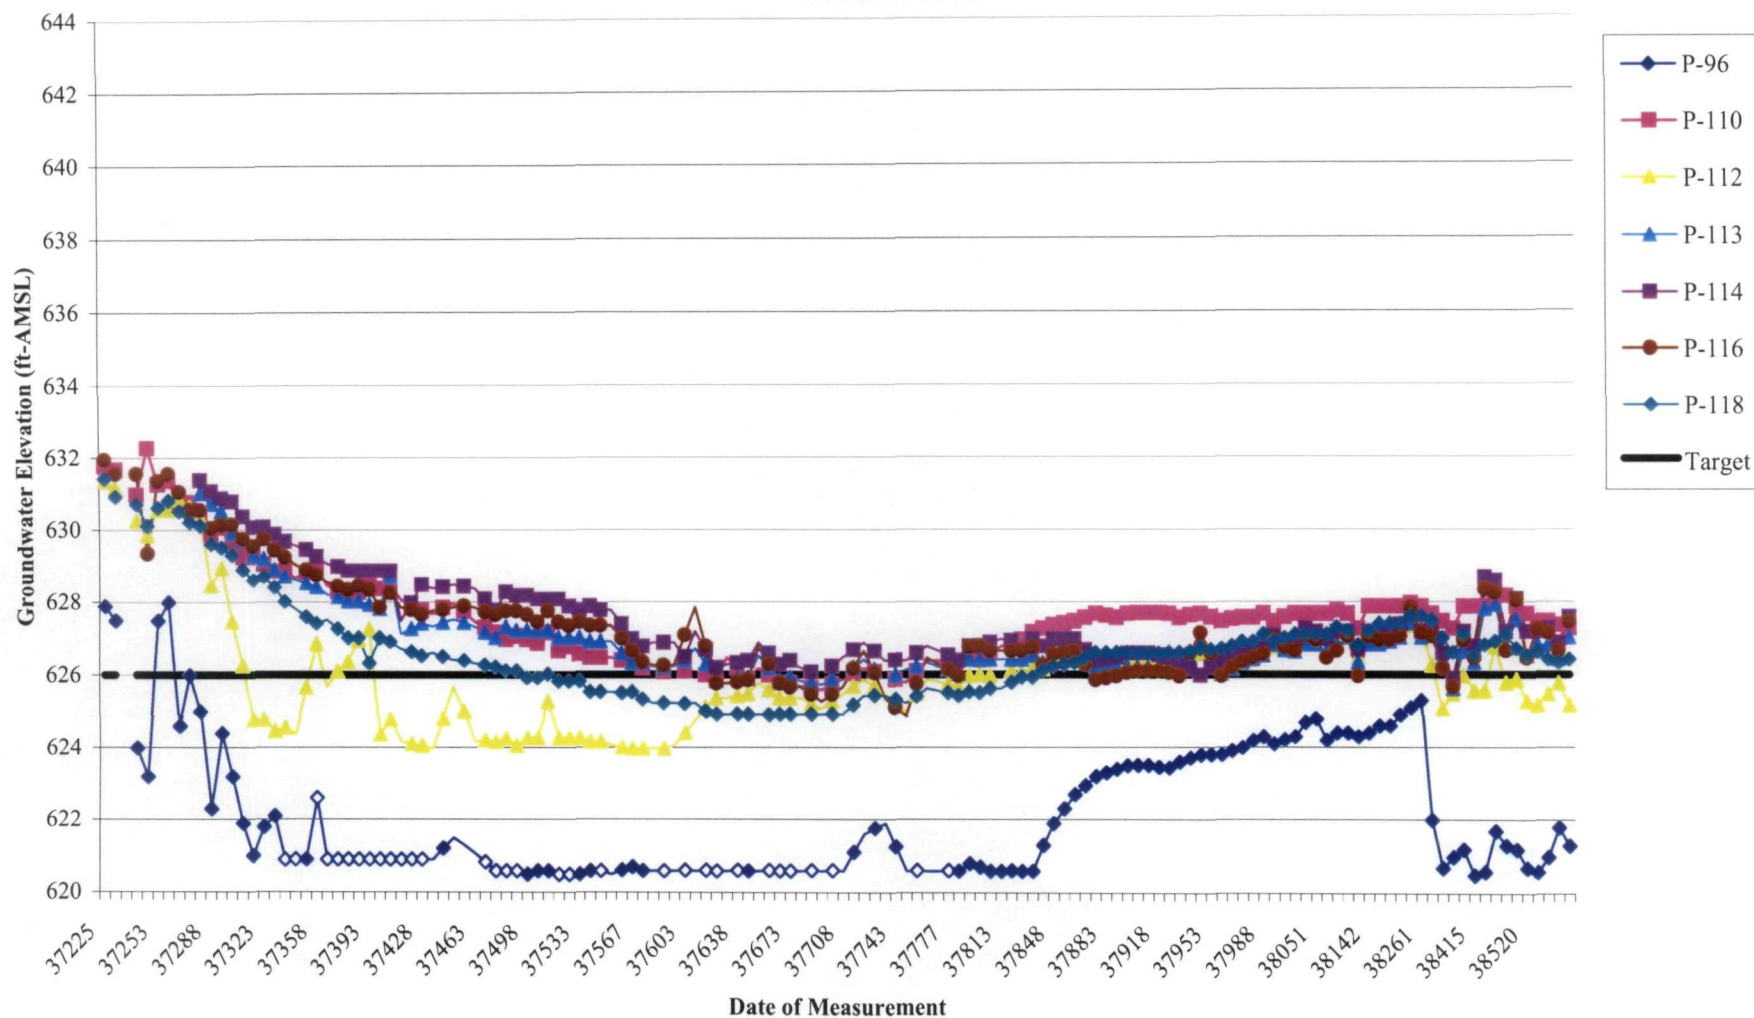
Figure 3
Off-Site Water Level Status - Piezometers
Groundwater Monitoring
ACS NPL Site
Griffith, Indiana

Hollow points represent dry piezometers
(data used for graphing purposes only). The bottom elevation of the piezometers may vary due to silting

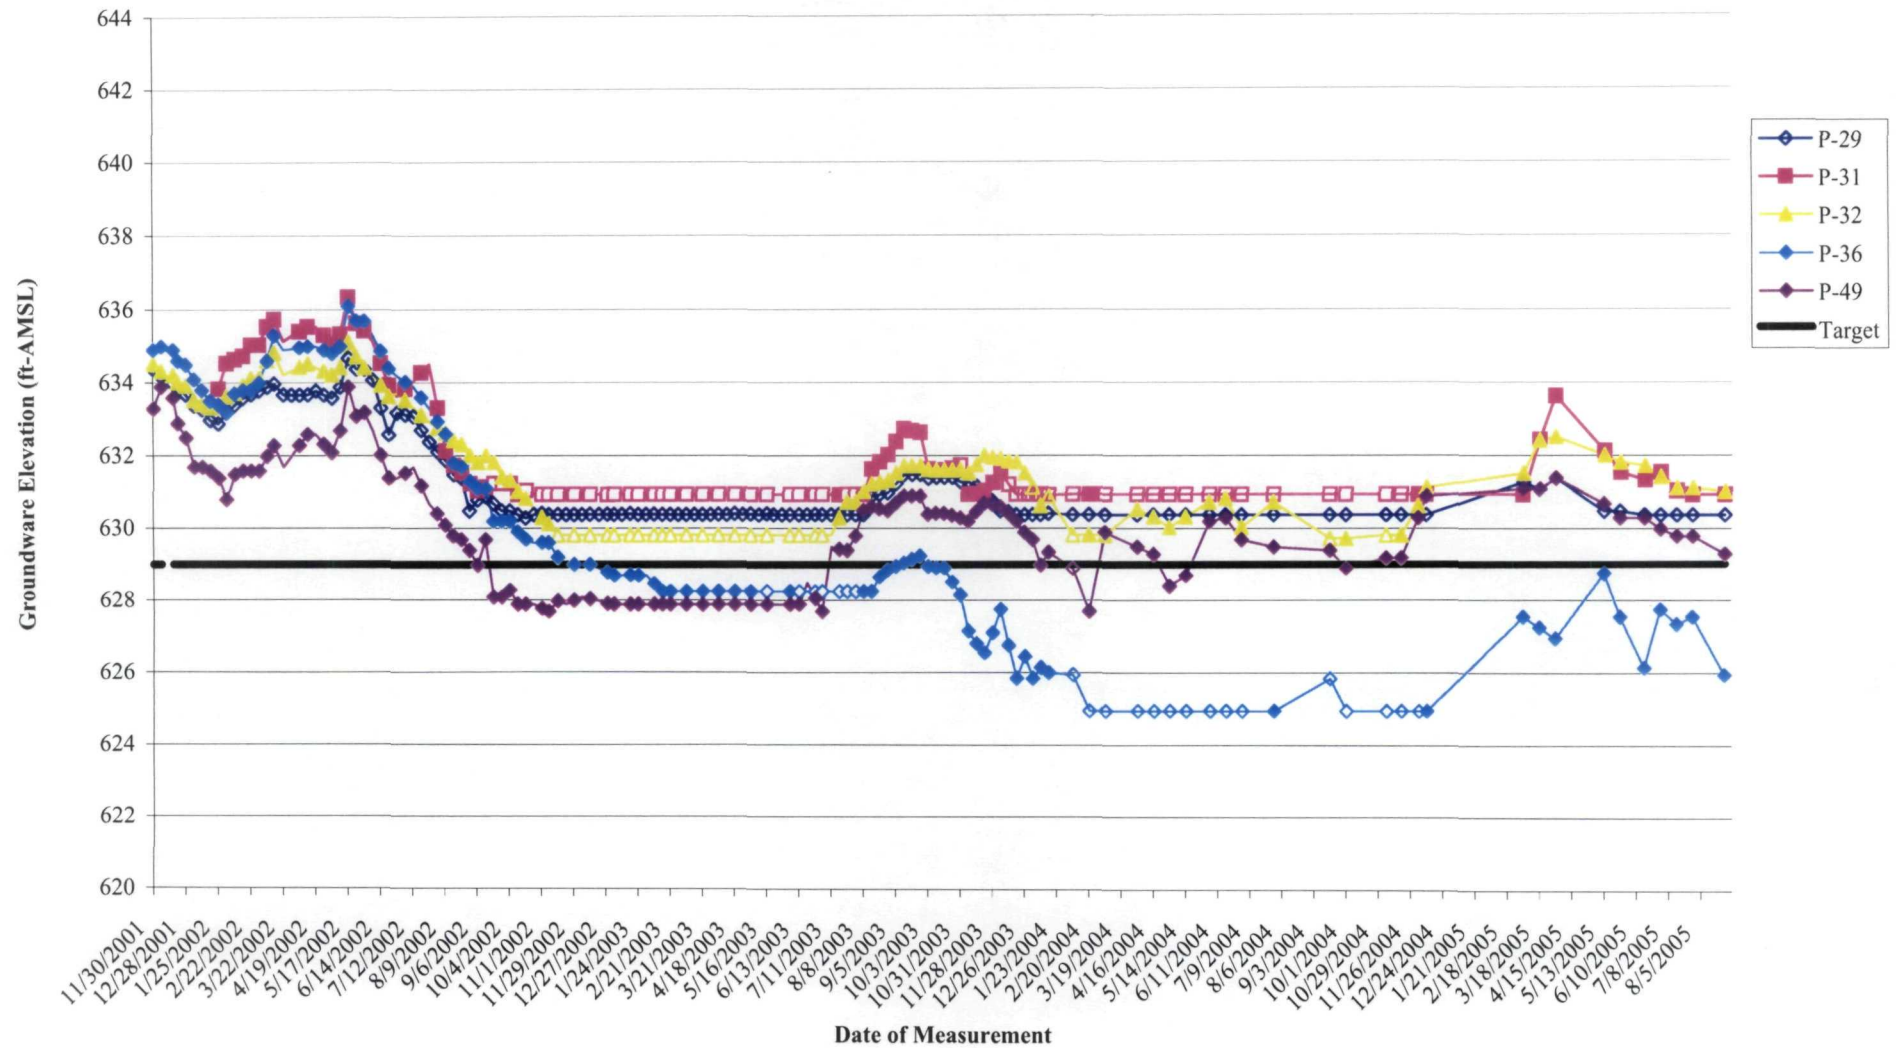
Figure 1
SBPA Water Level Status
ACS NPL Site
Griffith, Indiana

Hollow points represent dry piezometers (data used for graphing purposes only).

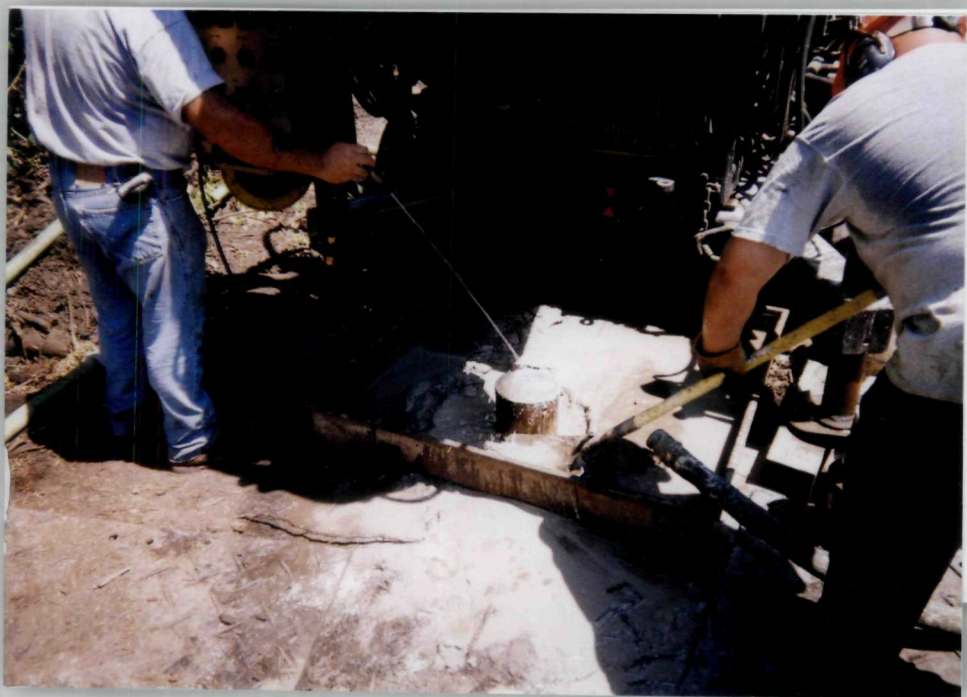
Site: American Chemical Service, Inc.
 Proj. #: 44728 AES [46526 RAC]
 Roll: 77 Photo #1
 Date: 08-01-05 Time: 1331
 Photographer: Larry Campbell
 Description: Photo facing east showing Boart cleaning sand from mud tub at LA11A (replacement well for abandoned LA11). Drilled casing to 14.5' bgs.

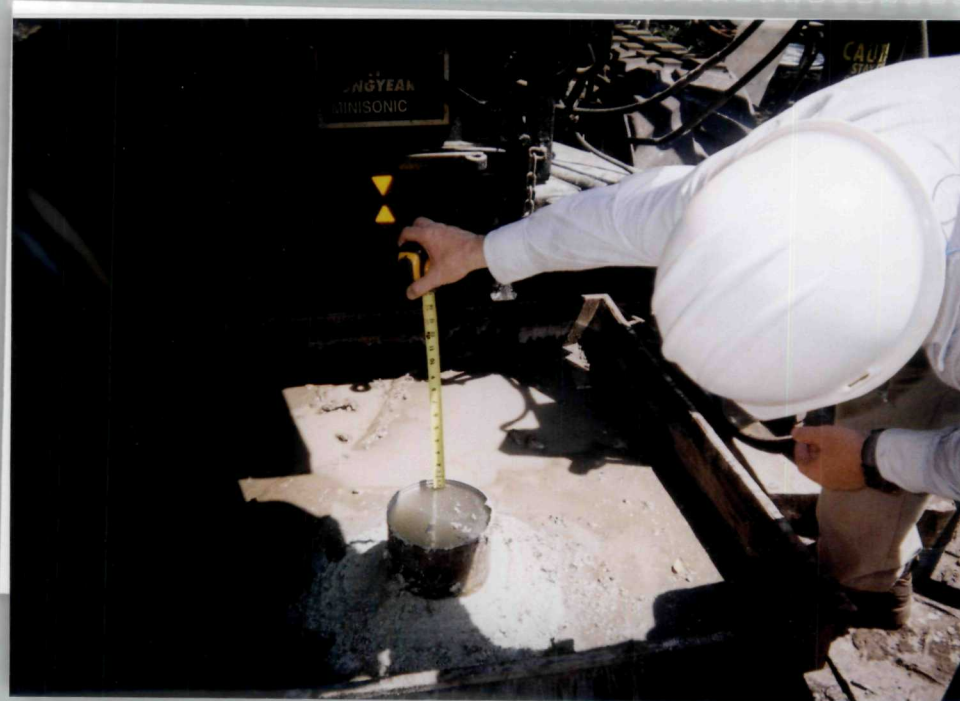
Site: American Chemical Service, Inc.
 Proj. #: 44728 AES [46526 RAC]
 Roll: 77 Photo #2
 Date: 08-01-05 Time: 1346
 Photographer: Larry Campbell
 Description: Photo facing east showing water holding test in casing. About 1/2" water loss in 15 minutes. Therefore, casing seal into clay is satisfactory.

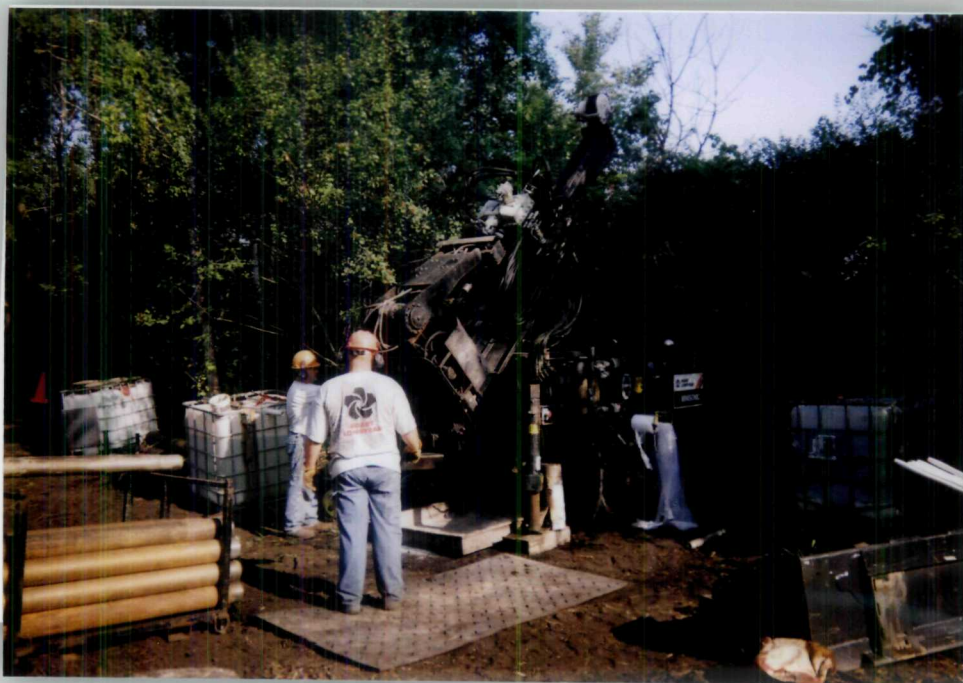
Site: American Chemical Service, Inc.
 Proj. #: 44728 AES [46526 RAC]
 Roll: 77 Photo #3
 Date: 08-09-05 Time: 0845
 Photographer: Larry Campbell
 Description: Photo facing northwest showing Boart
 setting mud tub at LA12.

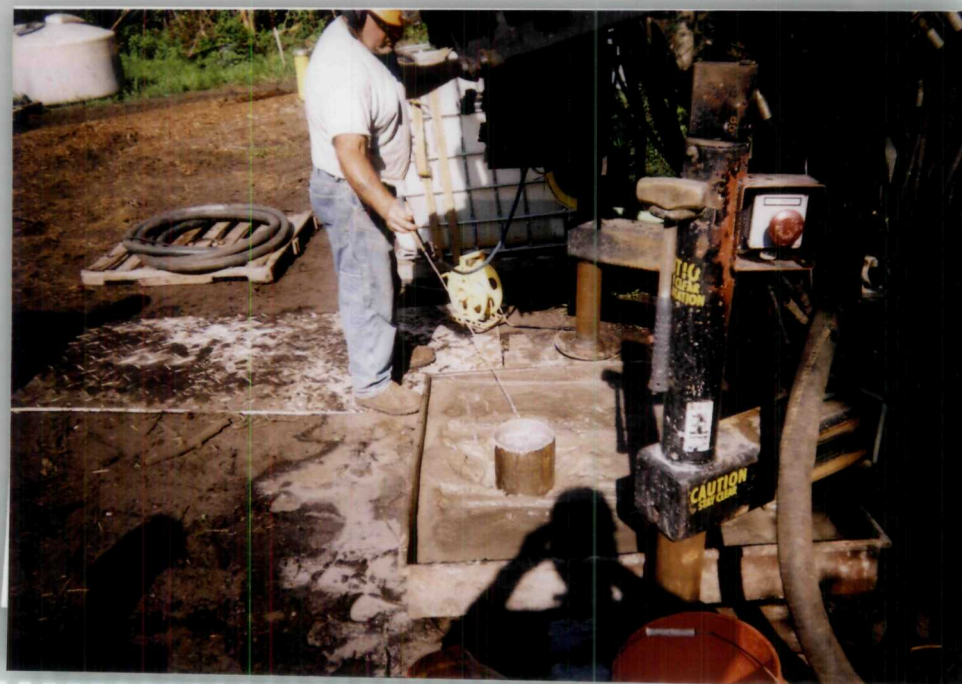
Site: American Chemical Service, Inc.
 Proj. #: 44728 AES [46526 RAC]
 Roll: 77 Photo #4
 Date: 08-09-05 Time: 0913
 Photographer: Larry Campbell
 Description: Photo facing west showing Boart filling 8"
 dia. casing (seated in clay at 14' bgs) with
 water for leak test.

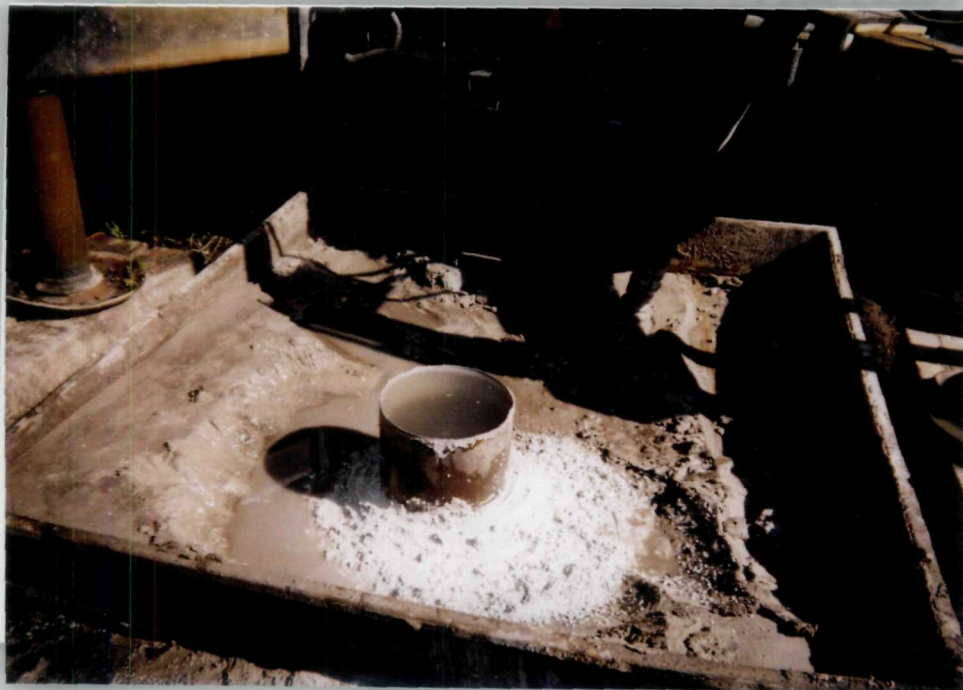
Site: American Chemical Service, Inc.
 Proj. #: 44728 AES [46526 RAC]
 Roll: 77 Photo #5
 Date: 08-09-05 Time: 0930
 Photographer: Larry Campbell

Description: Photo facing north showing 8"-dia. casing of LA12 during water leak test. Note only 1/8" water drop in 15 minutes; therefore test is good.

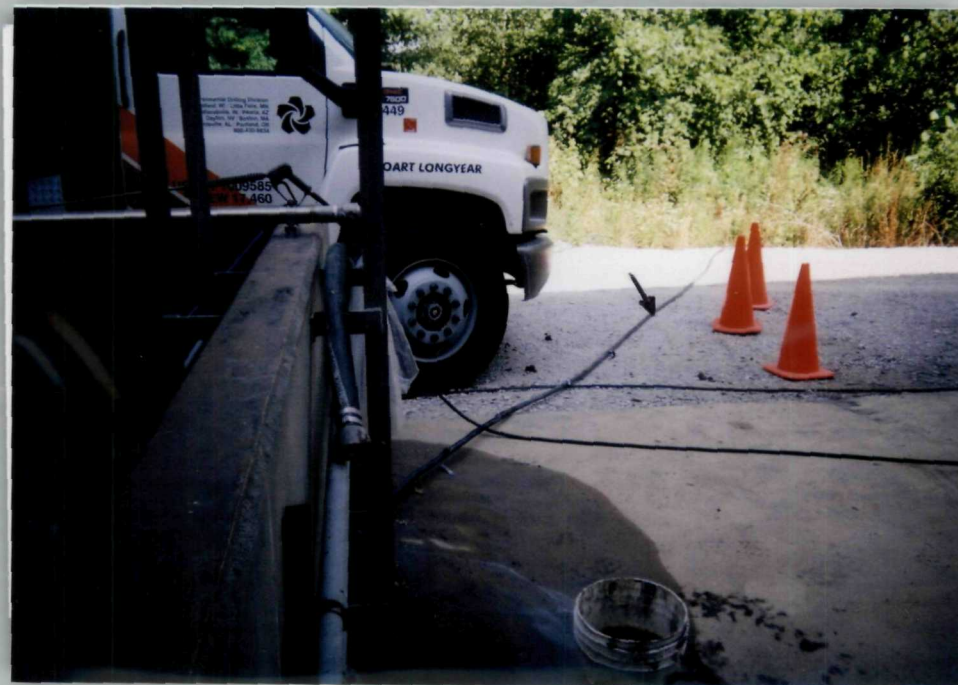
Site: American Chemical Service, Inc.
 Proj. #: 44728 AES [46526 RAC]
 Roll: 77 Photo #6
 Date: 08-09-05 Time: 1003
 Photographer: Larry Campbell

Description: Photo facing west showing 1"-dia. black plastic pipe (arrow) used to transfer recovered drill water from LA investigation area to GWTP.

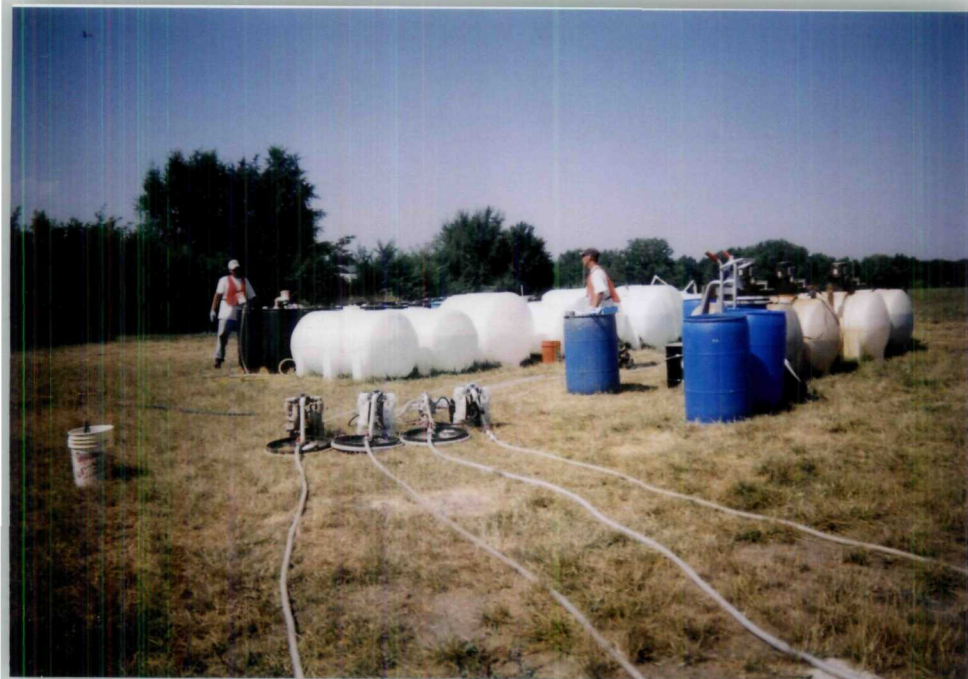
Site: American Chemical Service, Inc.
 Proj. #: 44728 AES [46526 RAC]
 Roll: 77 Photo #7
 Date: 08-09-05 Time: 1053
 Photographer: Larry Campbell
 Description: Photo facing southwest showing four ISCO pumps being used to inject fluids.

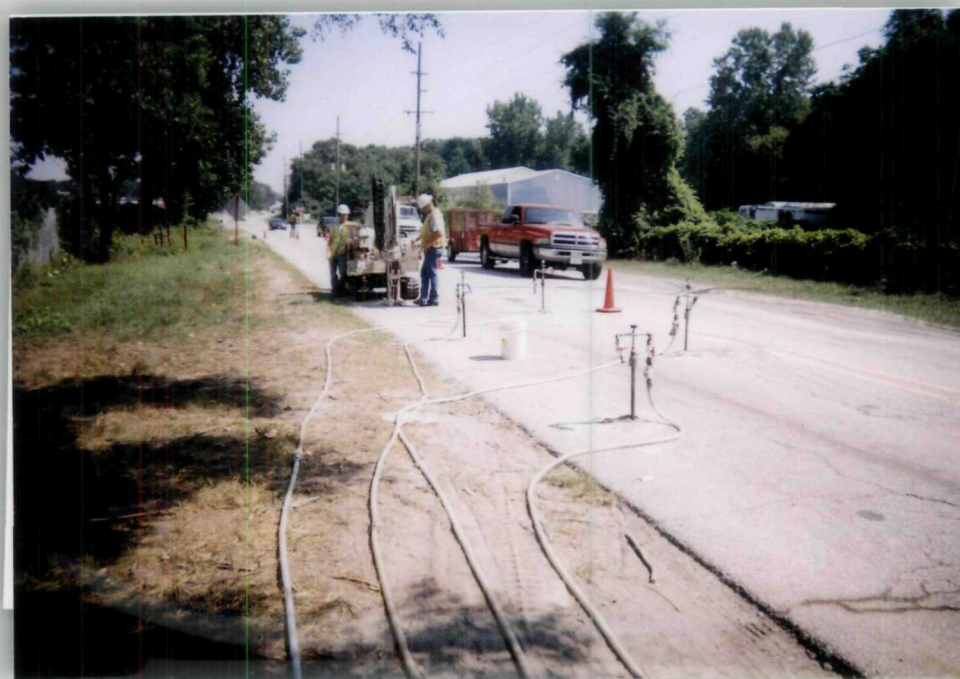
Site: American Chemical Service, Inc.
 Proj. #: 44728 AES [46526 RAC]
 Roll: 77 Photo #8
 Date: 08-09-05 Time: 1055
 Photographer: Larry Campbell
 Description: Photo facing north showing four injection points in west lane of Colfax Ave. being injected at same time. PSA is installing injection point in background.

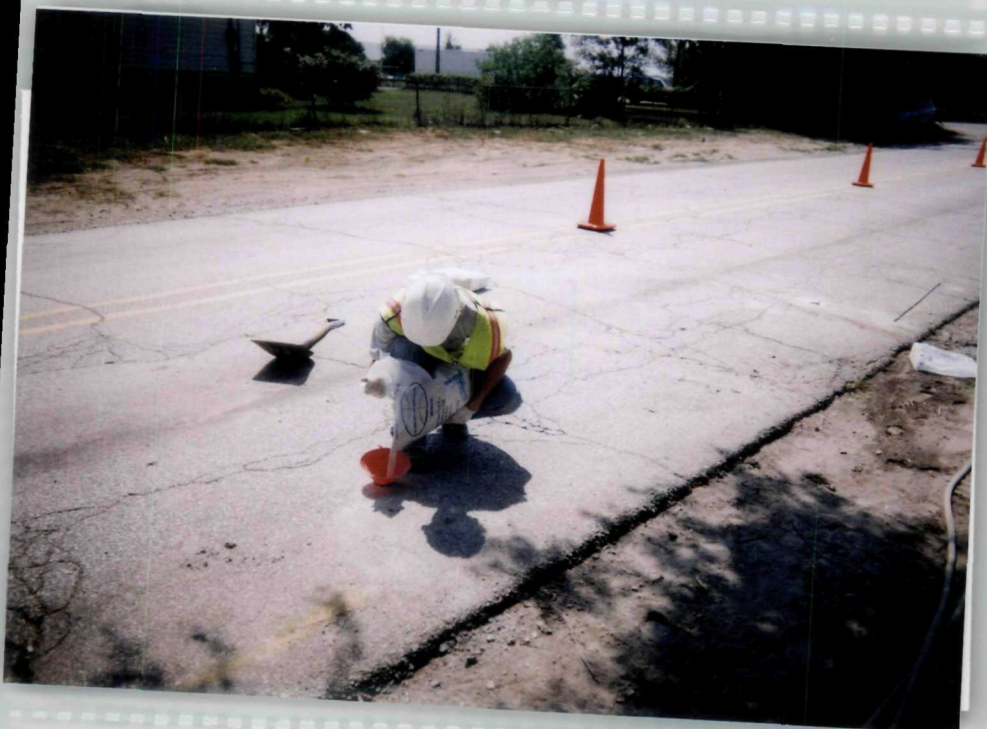
Site: American Chemical Service, Inc.
 Proj. #: 44728 AES [46526 RAC]
 Roll: 77 Photo #9
 Date: 08-09-05 Time: 1136
 Photographer: Larry Campbell
 Description: Photo facing southeast showing PSA
 backfilling injection point hole with sand.

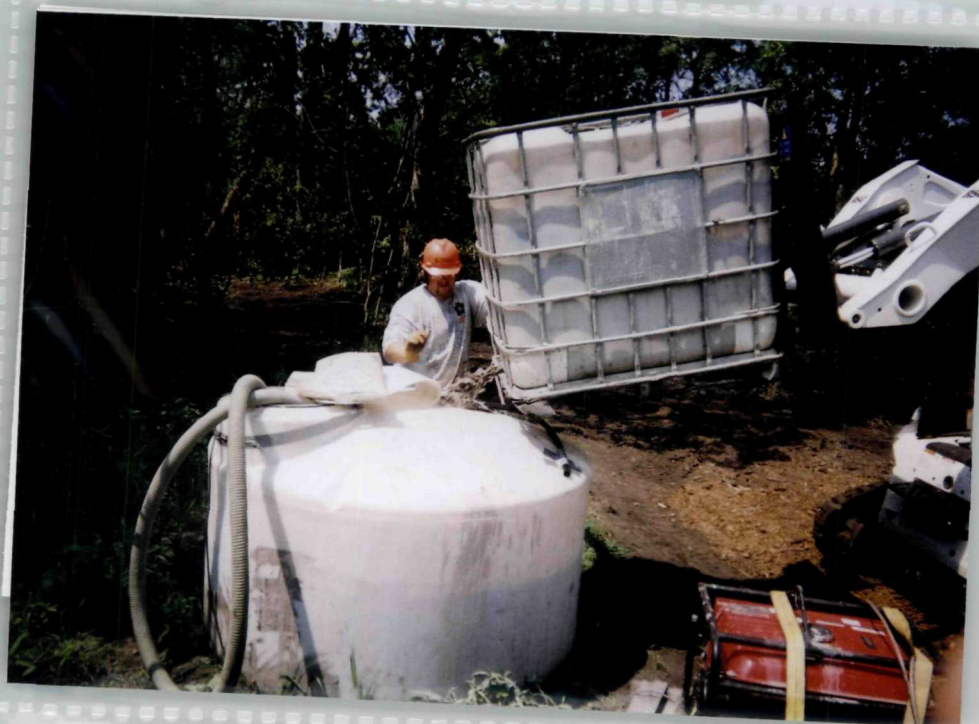
Site: American Chemical Service, Inc.
 Proj. #: 44728 AES [46526 RAC]
 Roll: 77 Photo #10
 Date: 08-09-05 Time: 1354
 Photographer: Larry Campbell
 Description: Photo facing northwest showing transfer of
 drill return water to holding tank for solids
 settlement and future transfer of liquid to
 GWTP.

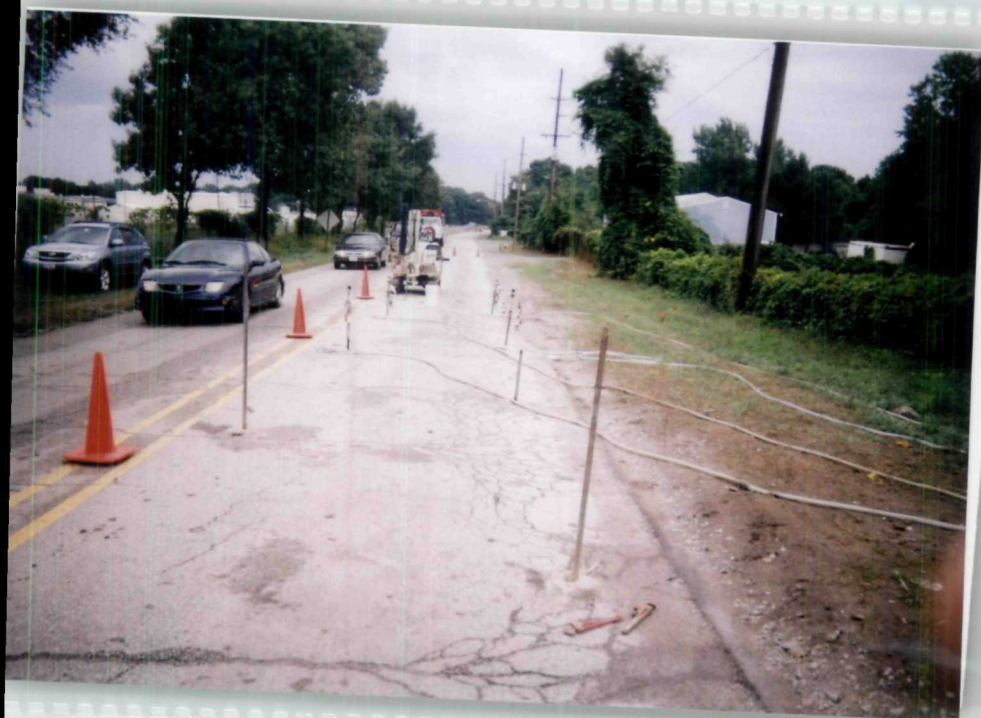
Site: American Chemical Service, Inc.
 Proj. #: 44728 AES [46526 RAC]
 Roll: 77 Photo #11
 Date: 08-11-05 Time: 1330
 Photographer: Larry Campbell
 Description: Photo facing north showing injection points
 in east lane of Colfax Ave.

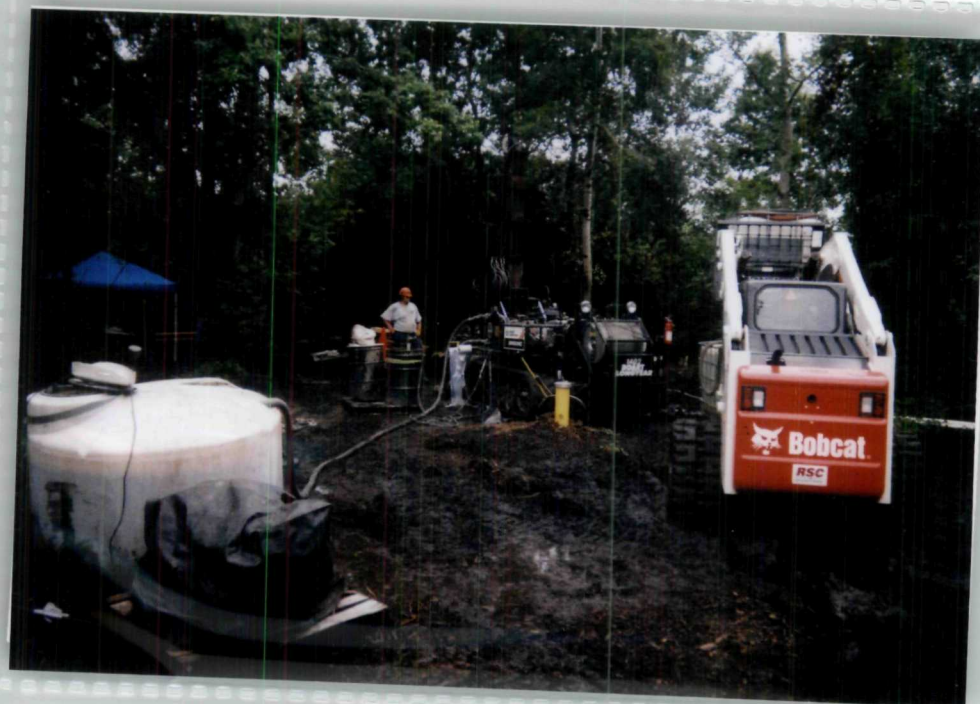
Site: American Chemical Service, Inc.
 Proj. #: 44728 AES [46526 RAC]
 Roll: 77 Photo #12
 Date: 08-11-05 Time: 1406
 Photographer: Larry Campbell
 Description: Photo facing northwest showing Boart set-
 up to drill extraction well. Note muddy
 conditions from recent rains.

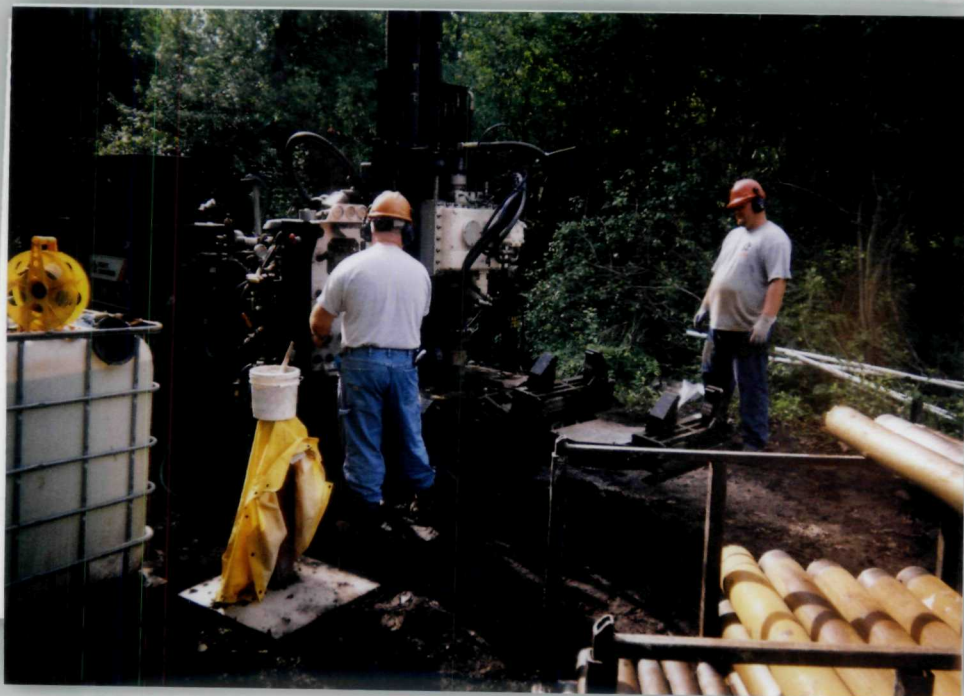
Site: American Chemical Service, Inc.
 Proj. #: 44728 AES [46526 RAC]
 Roll: 77 Photo #13
 Date: 08-15-05 Time: 0908
 Photographer: Larry Campbell
 Description: Photo facing southeast showing drill rig
 setting 8"-dia. casing for MW57.

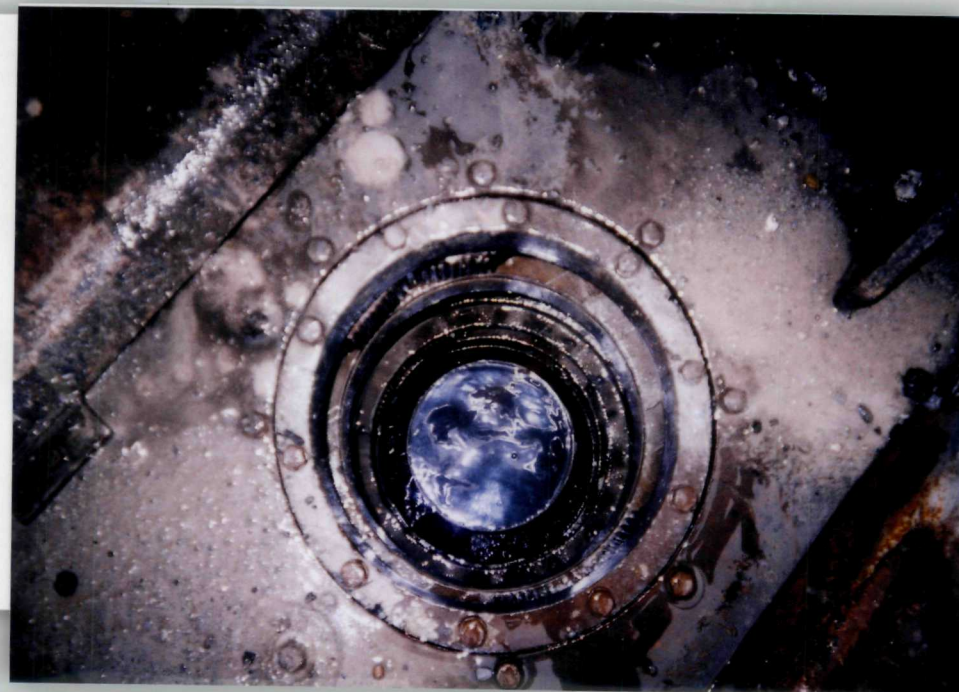
Site: American Chemical Service, Inc.
 Proj. #: 44728 AES [46526 RAC]
 Roll: 77 Photo #14
 Date: 08-15-05 Time: 0924
 Photographer: Larry Campbell
 Description: Photo facing downward through jaws of drill
 rig showing 8"-dia. casing containing water.

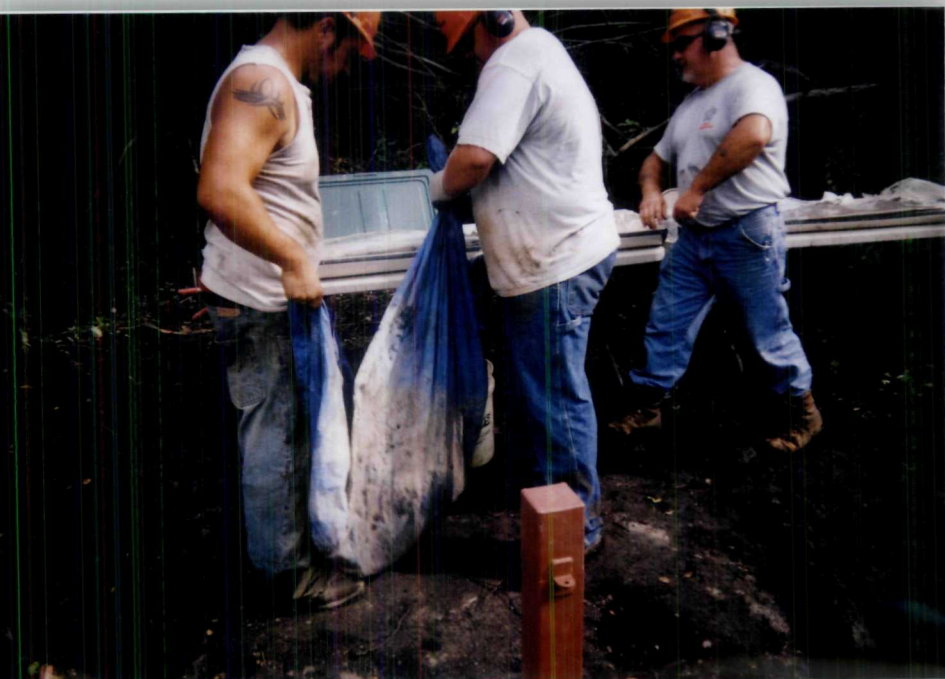
Site: American Chemical Service, Inc.
 Proj. #: 44728 AES [46526 RAC]
 Roll: 77 Photo #15
 Date: 08-15-05 Time: 0937
 Photographer: Larry Campbell
 Description: Photo facing north showing drillers mixing
 SakCrete in tarp to place in concrete
 surface pad at LA12.

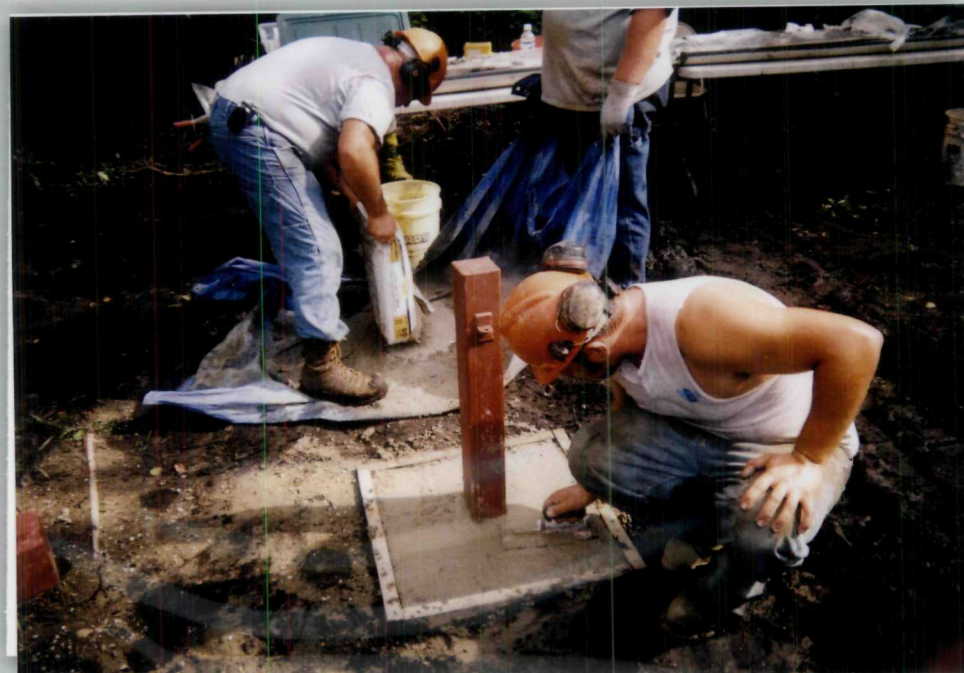
Site: American Chemical Service, Inc.
 Proj. #: 44728 AES [46526 RAC]
 Roll: 77 Photo #16
 Date: 08-15-05 Time: 0940
 Photographer: Larry Campbell
 Description: Photo facing north showing driller finishing
 concrete surface pad at LA12. Other driller
 in background is dumping another bag on
 SakCrete onto tarp for mixing.

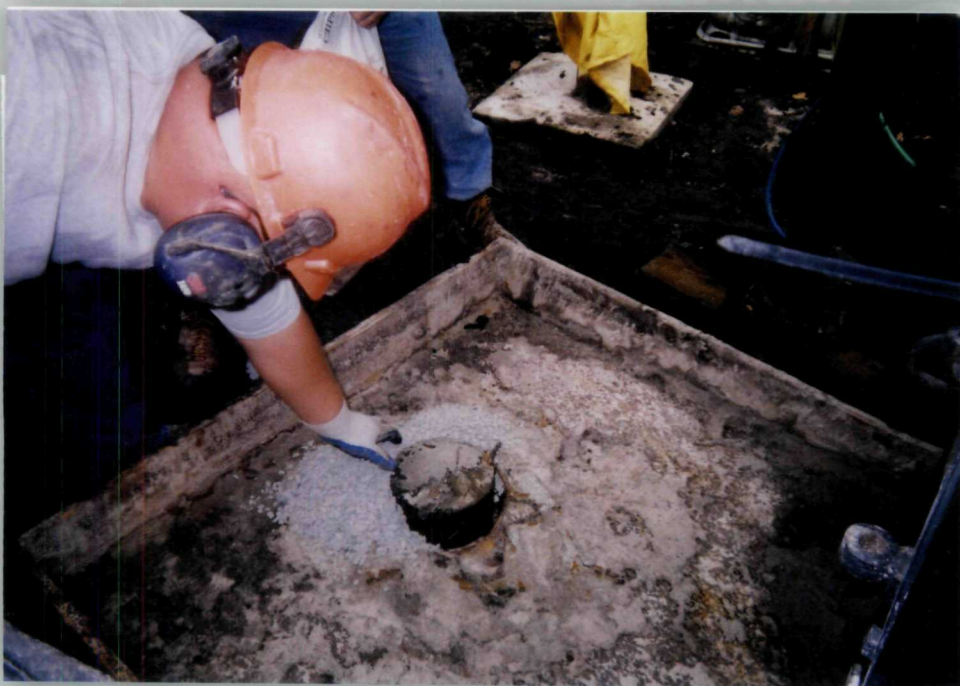
Description: Photo facing northwest showing water level in 8"-dia. casing. Driller is placing bentonite around casing to seal it to the mud pan.

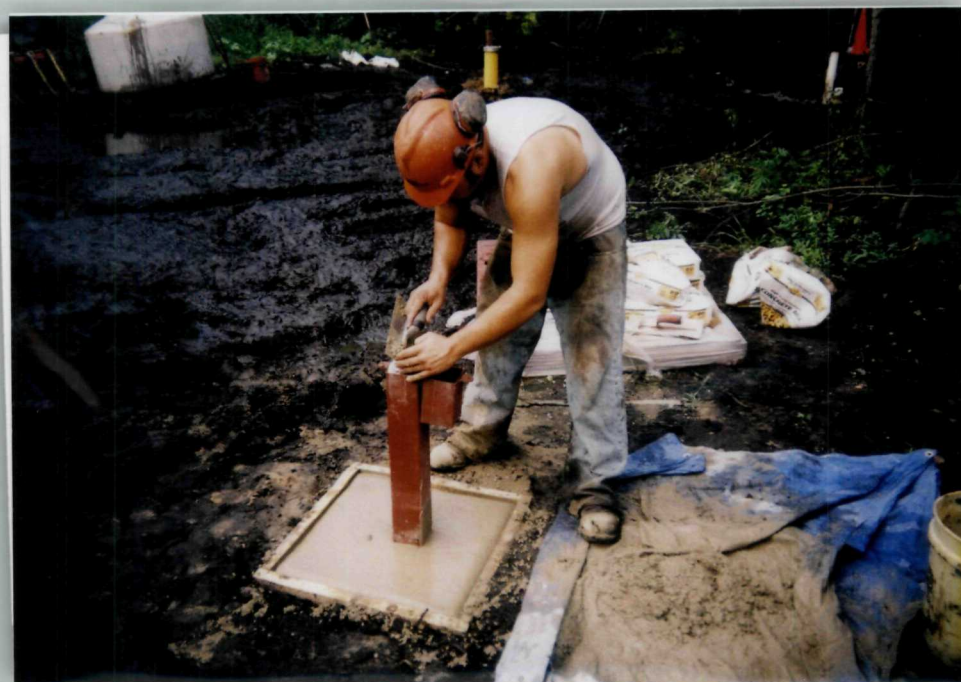
Description: Photo facing southwest showing driller placing concrete inside protective cap to seal casing.

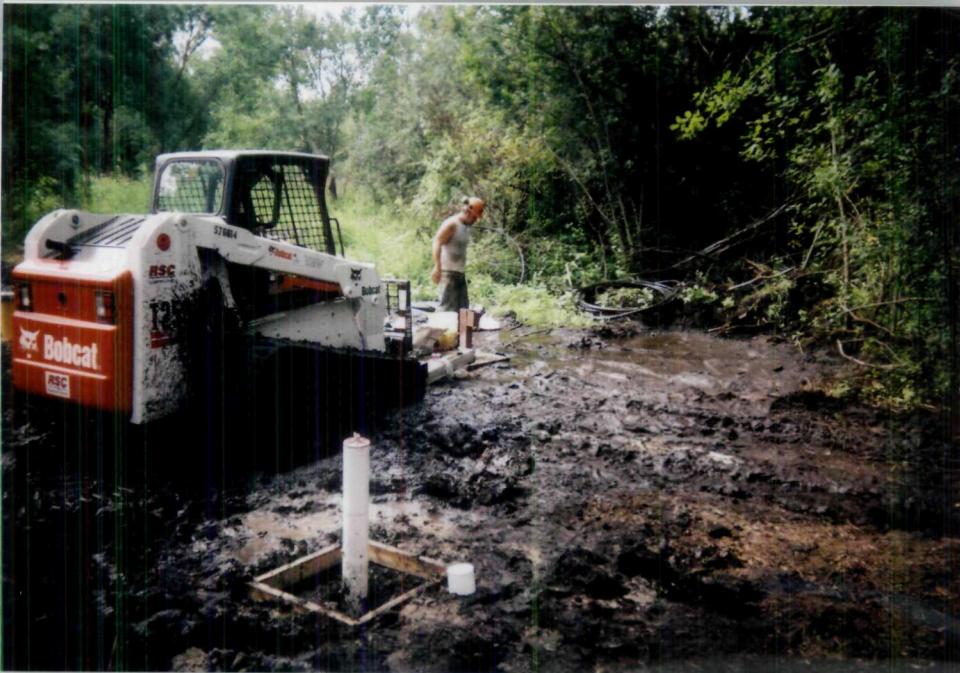
Site: American Chemical Service, Inc.
 Proj. #: 44728 AES [46526 RAC]
 Roll: 77 Photo #19
 Date: 08-15-05 Time: 1025
 Photographer: Larry Campbell
 Description: Photo facing south showing 4"-dia.
 extraction well EW2 (foreground). Driller
 placing concrete surface pad at OW1.

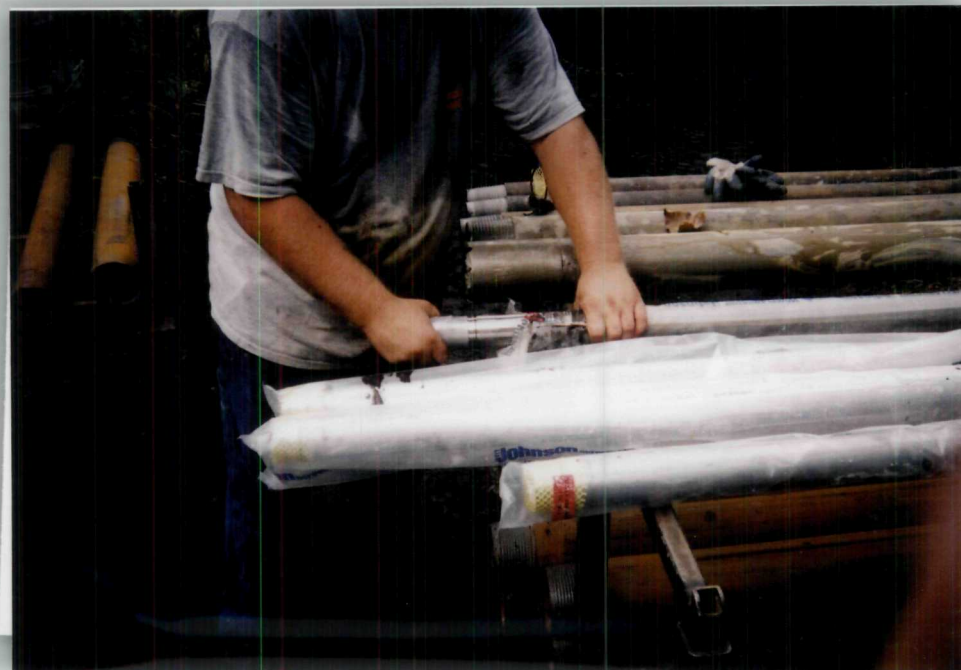
Site: American Chemical Service, Inc.
 Proj. #: 44728 AES [46526 RAC]
 Roll: 77 Photo #20
 Date: 08-15-05 Time: 1028
 Photographer: Larry Campbell
 Description: Photo facing south showing driller's helper
 screwing end cap on 2"-dia. stainless steel
 well screen to be installed as MW57.

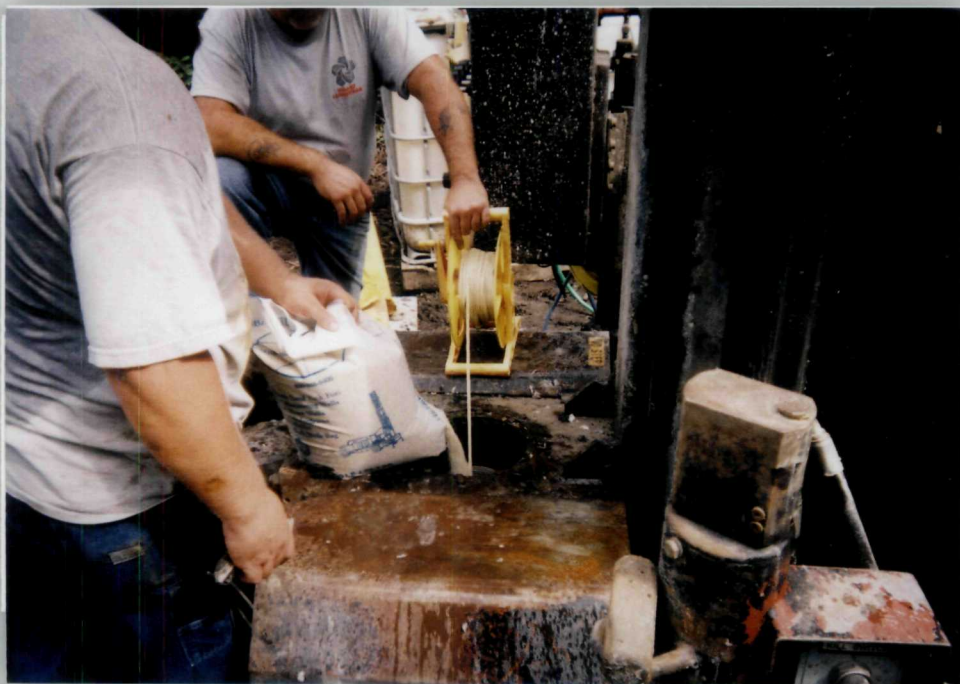
Site: American Chemical Service, Inc.
 Proj. #: 44728 AES [46526 RAC]
 Roll: 77 Photo #21
 Date: 08-15-05 Time: 1032
 Photographer: Larry Campbell
 Description: Photo facing north showing driller's helper adding sand to bottom of bore hole for MW57. Driller checking depth to top of sand with tape.

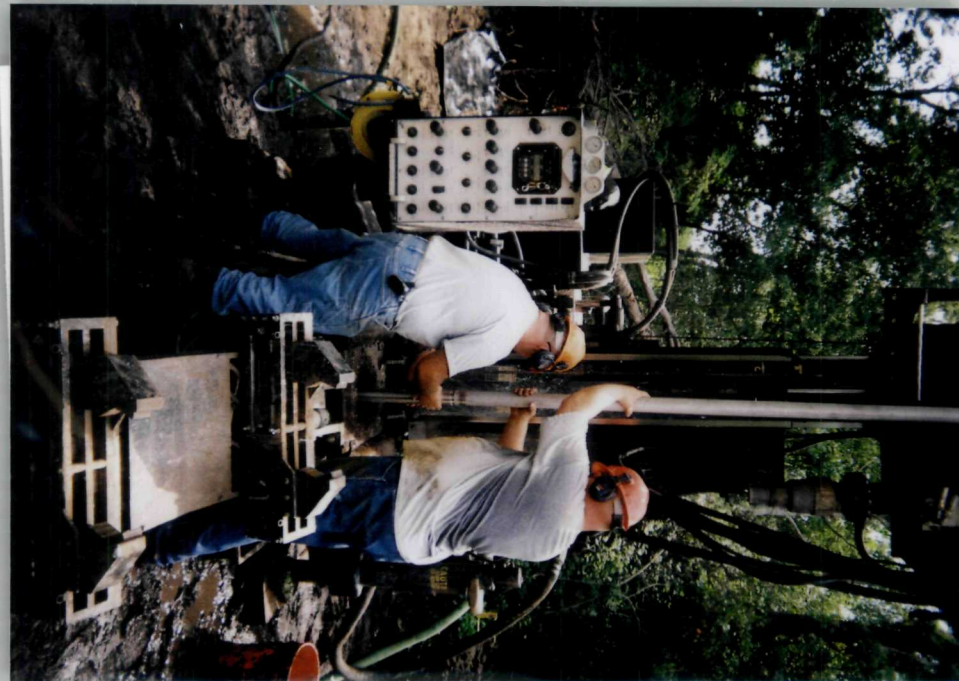
Site: American Chemical Service, Inc.
 Proj. #: 44728 AES [46526 RAC]
 Roll: 77 Photo #22
 Date: 08-15-05 Time: 1035
 Photographer: Larry Campbell
 Description: Photo facing east showing drillers screwing 2"-dia. stainless steel riser pipe to 2"-dia. SS well screen..

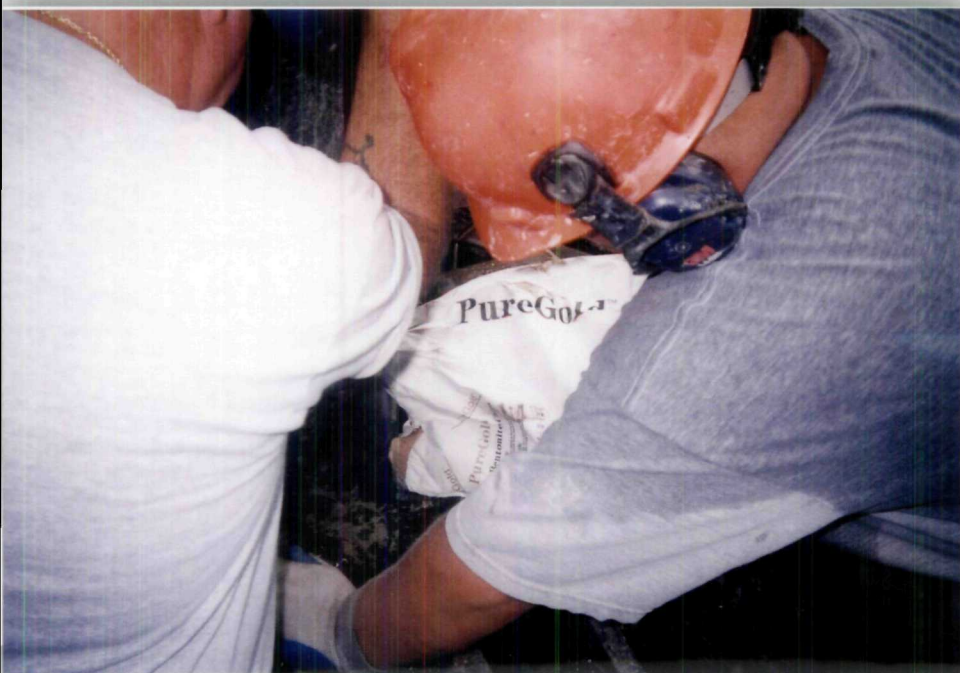
Site: American Chemical Service, Inc.
 Proj. #: 44728 AES [46526 RAC]
 Roll: 77 Photo #23
 Date: 08-15-05 Time: 1054
 Photographer: Larry Campbell
 Description: Photo facing east showing driller adding bentonite chips in MW57 above sand pack. Bottom of well set at 25' bgs.

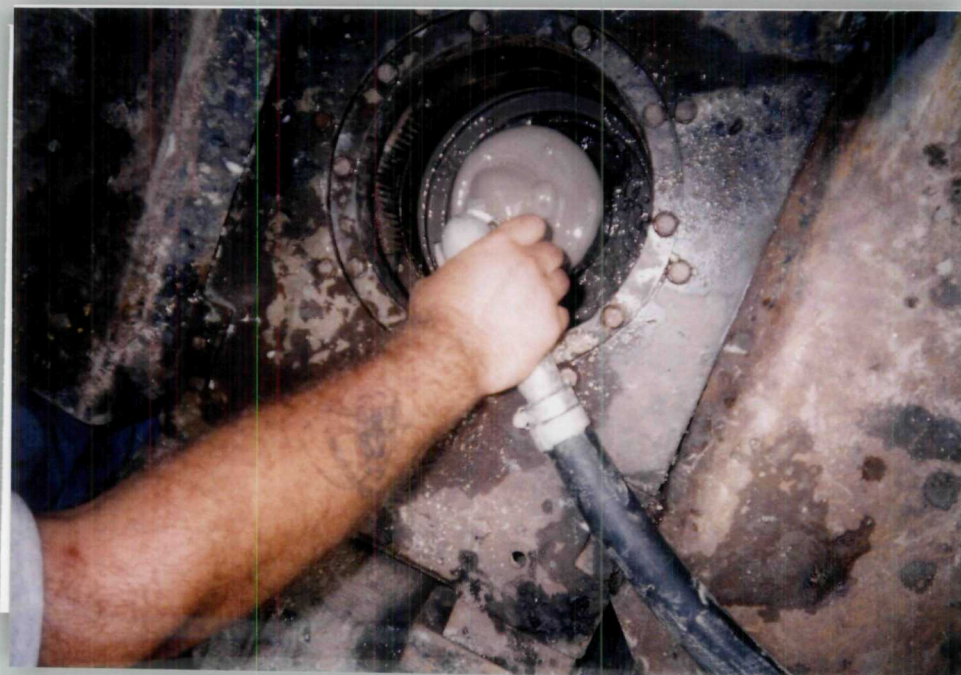
Site: American Chemical Service, Inc.
 Proj. #: 44728 AES [46526 RAC]
 Roll: 77 Photo #24
 Date: 08-15-05 Time: 1109
 Photographer: Larry Campbell
 Description: Photo facing downward through jaws of drill rig into MW57 showing placement of bentonite grout using PVC tremie pipe.

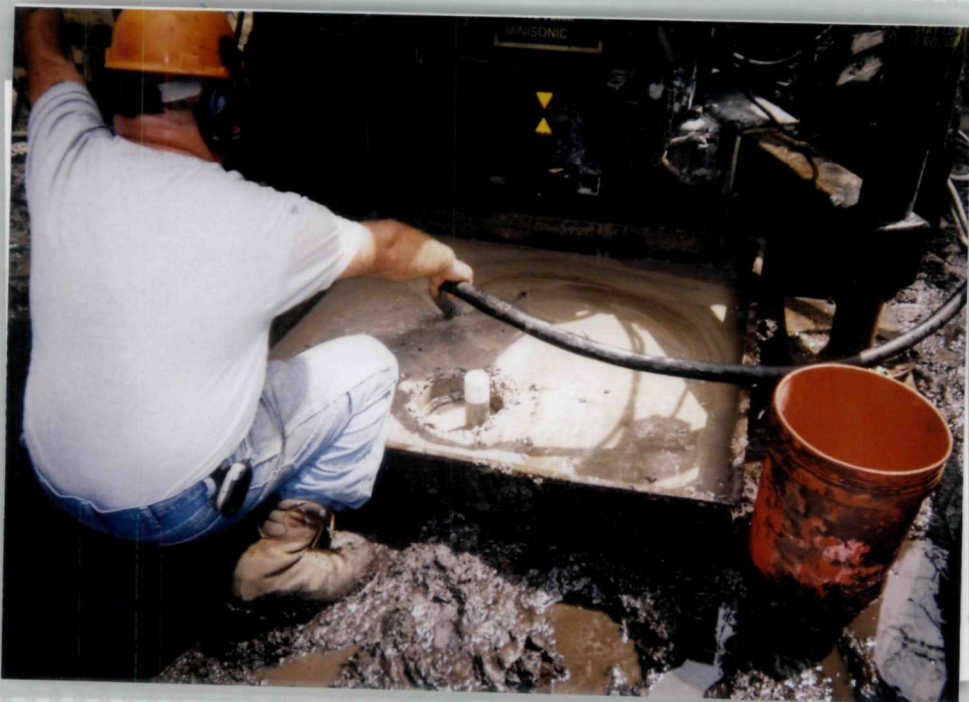
Site: American Chemical Service, Inc.
 Proj. #: 44728 AES [46526 RAC]
 Roll: 77 Photo #25
 Date: 08-15-05 Time: 1124
 Photographer: Larry Campbell

Description: Photo facing downward showing driller adding more bentonite grout to fill annulus around SS riser after removing surface casing.

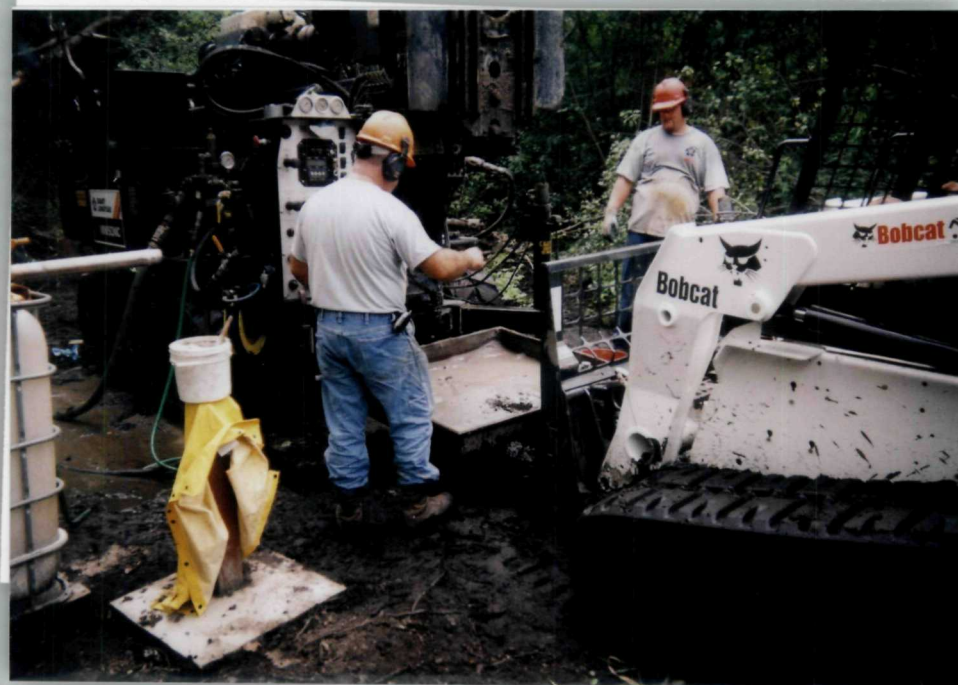
Site: American Chemical Service, Inc.
 Proj. #: 44728 AES [46526 RAC]
 Roll: 77 Photo #26
 Date: 08-15-05 Time: 1126
 Photographer: Larry Campbell

Description: Photo facing east showing bobcat removing mud pan from MW57 borehole.
